FINAL REPORT

Project Title: *Scaling and Self-Sensing in Composite Repairs of Corrosion Defects*

Prepared by: *The University of Tulsa*

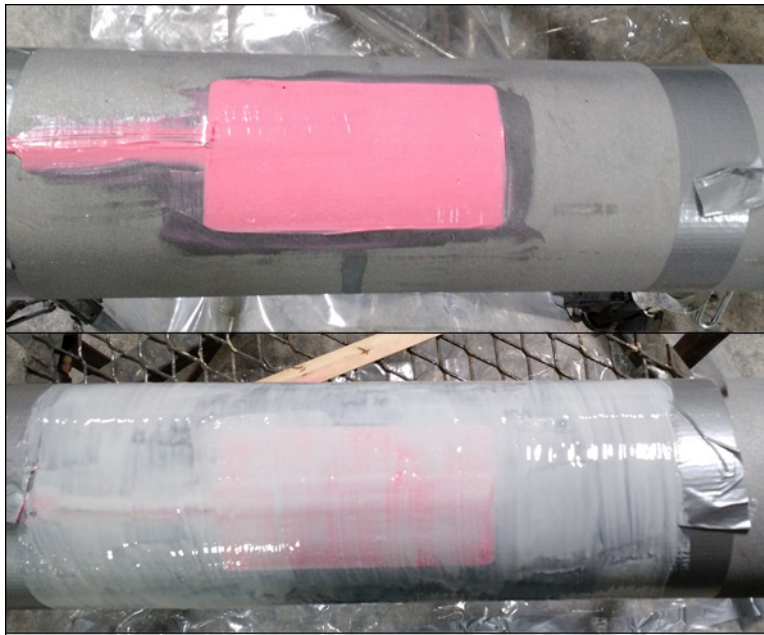
substrate and promote adhesion between the composite and the steel. Figure 1.1 shows a damaged pipe section with putty applied (top, color pink) and with primer applied (bottom, color gray).

**Figure 1.1: Damaged pipe section with restoration putty applied (top),
the same damaged section with primer applied (bottom)**

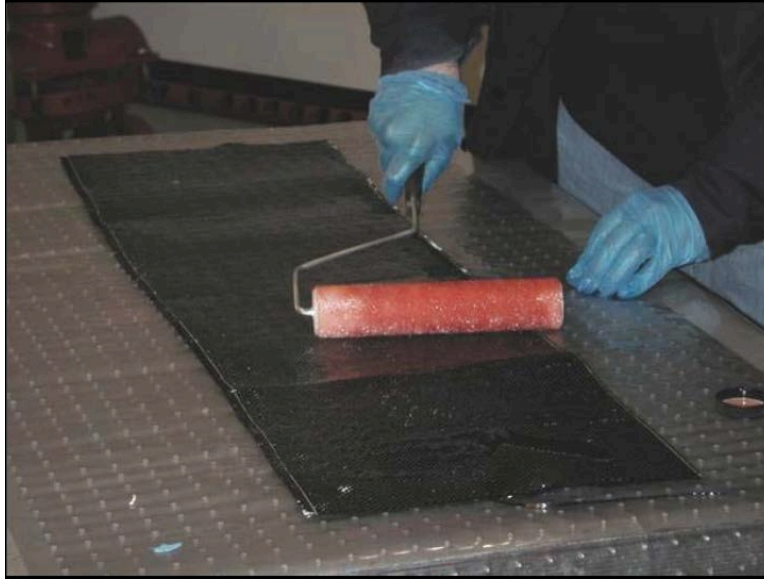
At this point, the substrate is ready for the composite material to be installed over the defect zone. The installation process begins with the saturation of the reinforcement fiber with the matrix material. Figure 1.2 shows this process, known as the wetout process, being completed where a paint roller is used to apply an epoxy matrix to a carbon fiber reinforcement.

Figure 1.2: Example of the wetout process. The epoxy is being spread onto a piece of carbon fiber using a paint roller [13]

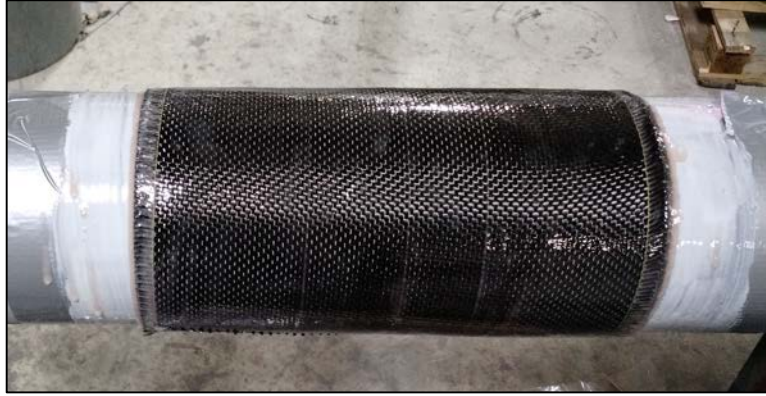
After the reinforcement is saturated with the matrix material, the composite is ready for application. The wetted composite is wrapped around the previously prepared section. The process of wetout and application is repeated until the desired repair thickness is reached. A newly installed repair is frequently wrapped in a plastic stretch film to help consolidate the composite. After completing the installation, the composite is allowed to cure for a specified minimum duration, typically 24 hours. Once fully cured, the damaged section of pipe is considered repaired and ready to be returned to its fully operational online state. Figure 1.3 shows an example of a cured repair ready to be returned to its working state.

Figure 1.3: Example of a carbon composite repair installed on a damaged pipe section

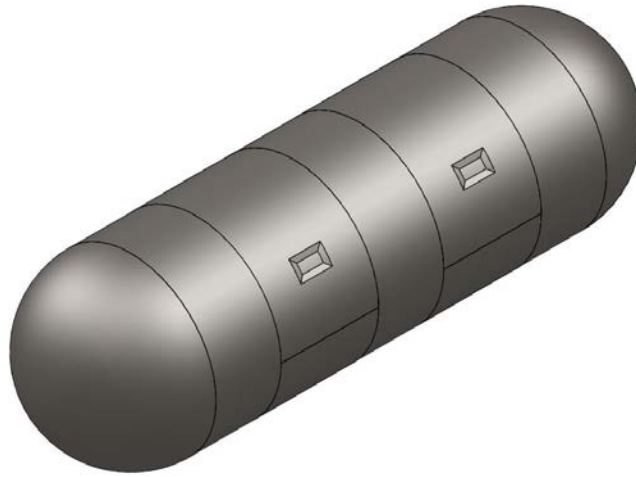
to replace those scrapped vessels. The replacement vessel was fabricated using rolled and welded flat A36 steel sheets with defects that were machined prior to welding. A schematic of the pressure vessel is shown in Figure 3.4.

Figure 3.4: Schematic overview of large-scale (42" diameter) pressure vessel.

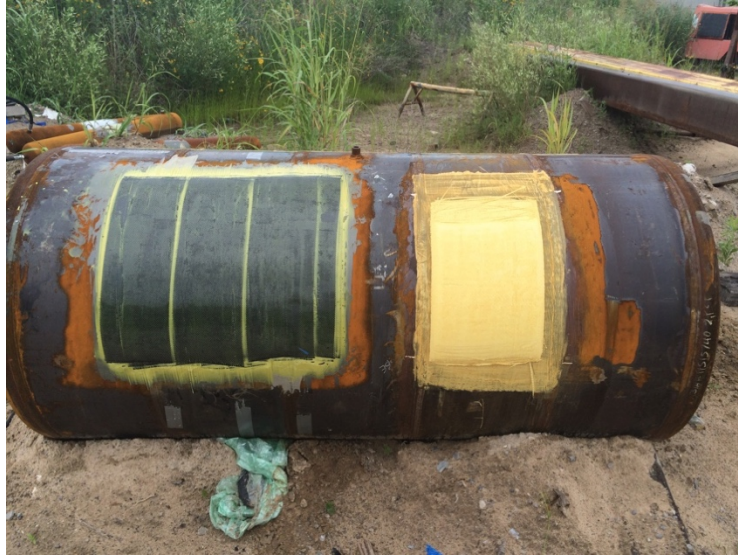
Figure 3.6: 42-inch vessel with installed patches.

Test pieces were first rolled to ensure that the rolling process would not distort the defect significantly. After this test demonstrated that this was a viable fabrication approach, the full vessel was fabricated and the participants installed repairs on the test vessel. The completed vessel with installed repairs is shown in Figure 3.6.
